JETTALK

Customer Newsletter | Spring 2020

SERVICE BULLETIN #111

Teleradial Bridge Cab Rotation Pivot Inspection

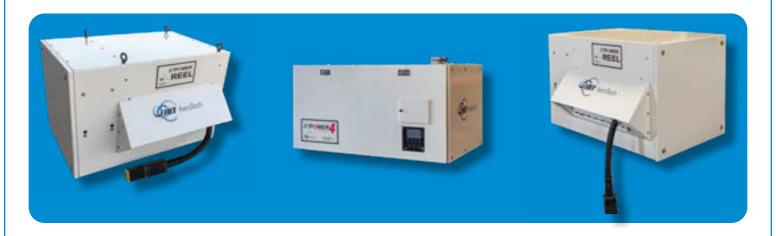
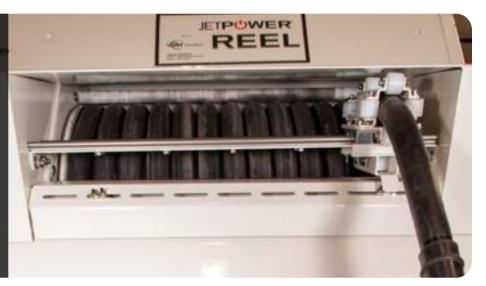
JBT's Jetpower® Cable Reel is an innovative product designed to simplify the everyday operation of your Jetpower units. With its great reliability, simple and robust design, and easy operation, it's your "reel" cable solution.

Simplifies 400 Hz cable management - turn off the APU faster

> One touch power activation

Deploy only the cable needed

Less exertion for ground crews - assists with cable movement

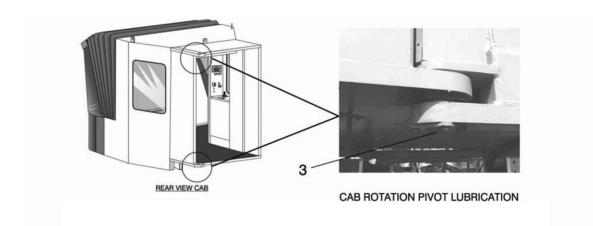
Figure 1

No Lube		Description	Frequency			Remarks
Spec	Q		S	Α	Nemarks	
1	3	Drive Chains	Х			
2	3	Sprocket Shaft	Х			
3	1	Side Pivot Point			Χ

(Lubrication recommendation of cab rotation pivot from Section 2-3, Teleradial Multifunctional Passenger Boarding Bridge Operation and Maintenance Manual, TP100006)

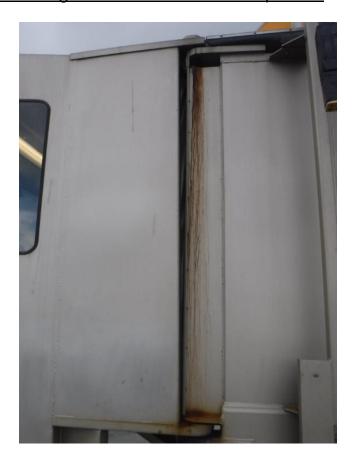
1. Visually check for any rust and rusty water stains. This could indicate possible pin or bushing corrosion issues. If there are corrosion indicators as shown in Figure 2 below, there is likely excessive wear on the cab pin and/or bushing due to a lack of lubrication.

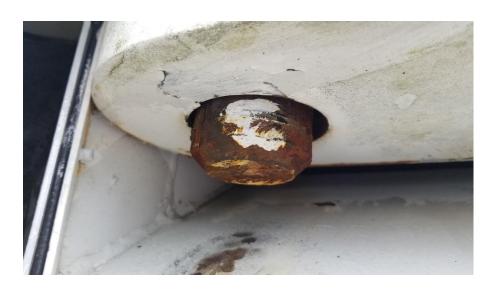
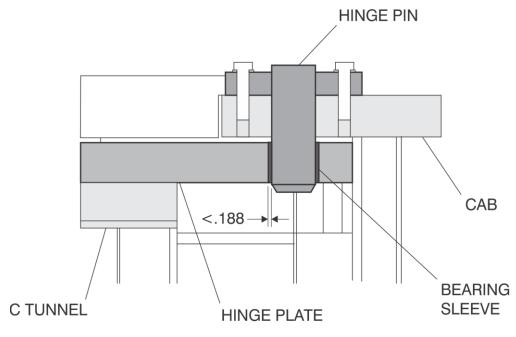
- 2. Visually inspect the bearing sleeve for wear on both the upper and lower hinge plates. If the pin is directly touching the inside of the hole in the hinge plate, the bearing is worn out. If the bearing is there, then perform the following measurement procedures.
- 3. With the bridge cab aligned with the C tunnel, measure the minimum gap between the outside diameter of the pin and the inside edge of the hole in the upper hinge plate attached to the C tunnel shown in Figure 3 or to the lower hinge plate attached to the cab as in Figure 4.

Because it is a tight fit, if the gap between the edge of the pin and the hole in the hinge plate is less than 0.188 inches, there is wear erosion on the sleeve. See Figures 3 and 4.

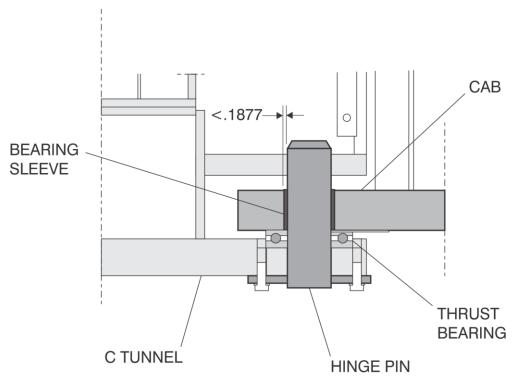
Figure 4

The diameter of the hole in the hinge plate should be 2.63 inches. The bearing sleeve has an inside diameter of 2.25 inches and an outside diameter of 2.63 inches. The upper and lower hinge pin diameter is 2.25 inches.

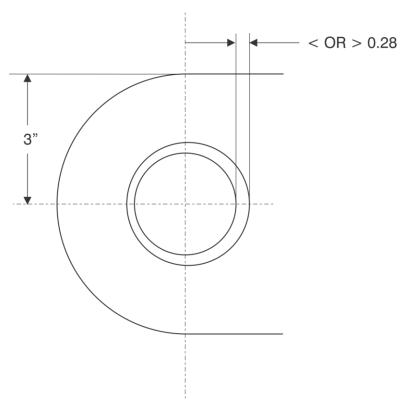
a. If the maximum gap is less than 0.28 (Figure 5), the bearing sleeve is worn less than half way through and can continue to operate. Lubricate, inspect and measure the distance annually.

b. If the maximum gap is greater than 0.28 (Figure 5), the bearing sleeve is either worn out or more than half way through and should be replaced.

NOTE: If the lower hinge plate falls outside the tolerance in Figure 5 and stated in step 4, contact JBT for consultation.

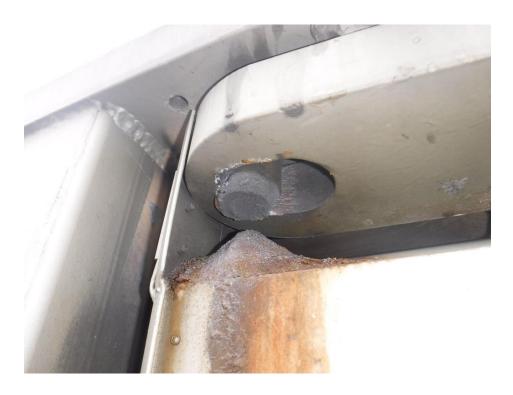
Figure 6

- 4. If the bearing is all worn out and non-existent, measure the largest diameter of the hole in the hinge plate (it may be oval shape). If the largest diameter is 2.63 inches (original hinge pin hole diameter), the procedure will only require the replacement of the bearing sleeve.
- 5. If there is too much wear on the pin hole in the upper hinge plate, the hinge plate will need to be cut and replaced. See Figure 6.

To replace the upper cab hinge plate (ear bracket):

- a. Remove the bridge cab.
- b. Using an air arch, remove the damaged hinge plate from the tubing.
- c. Align the new hinge plate (2130427, shown in Figure 7) with the hinge pin as shown in Figure 8.
